Intended Consequences

The Atomic Bombings

HIROSHIMA AND NAGASAKI, JAPAN

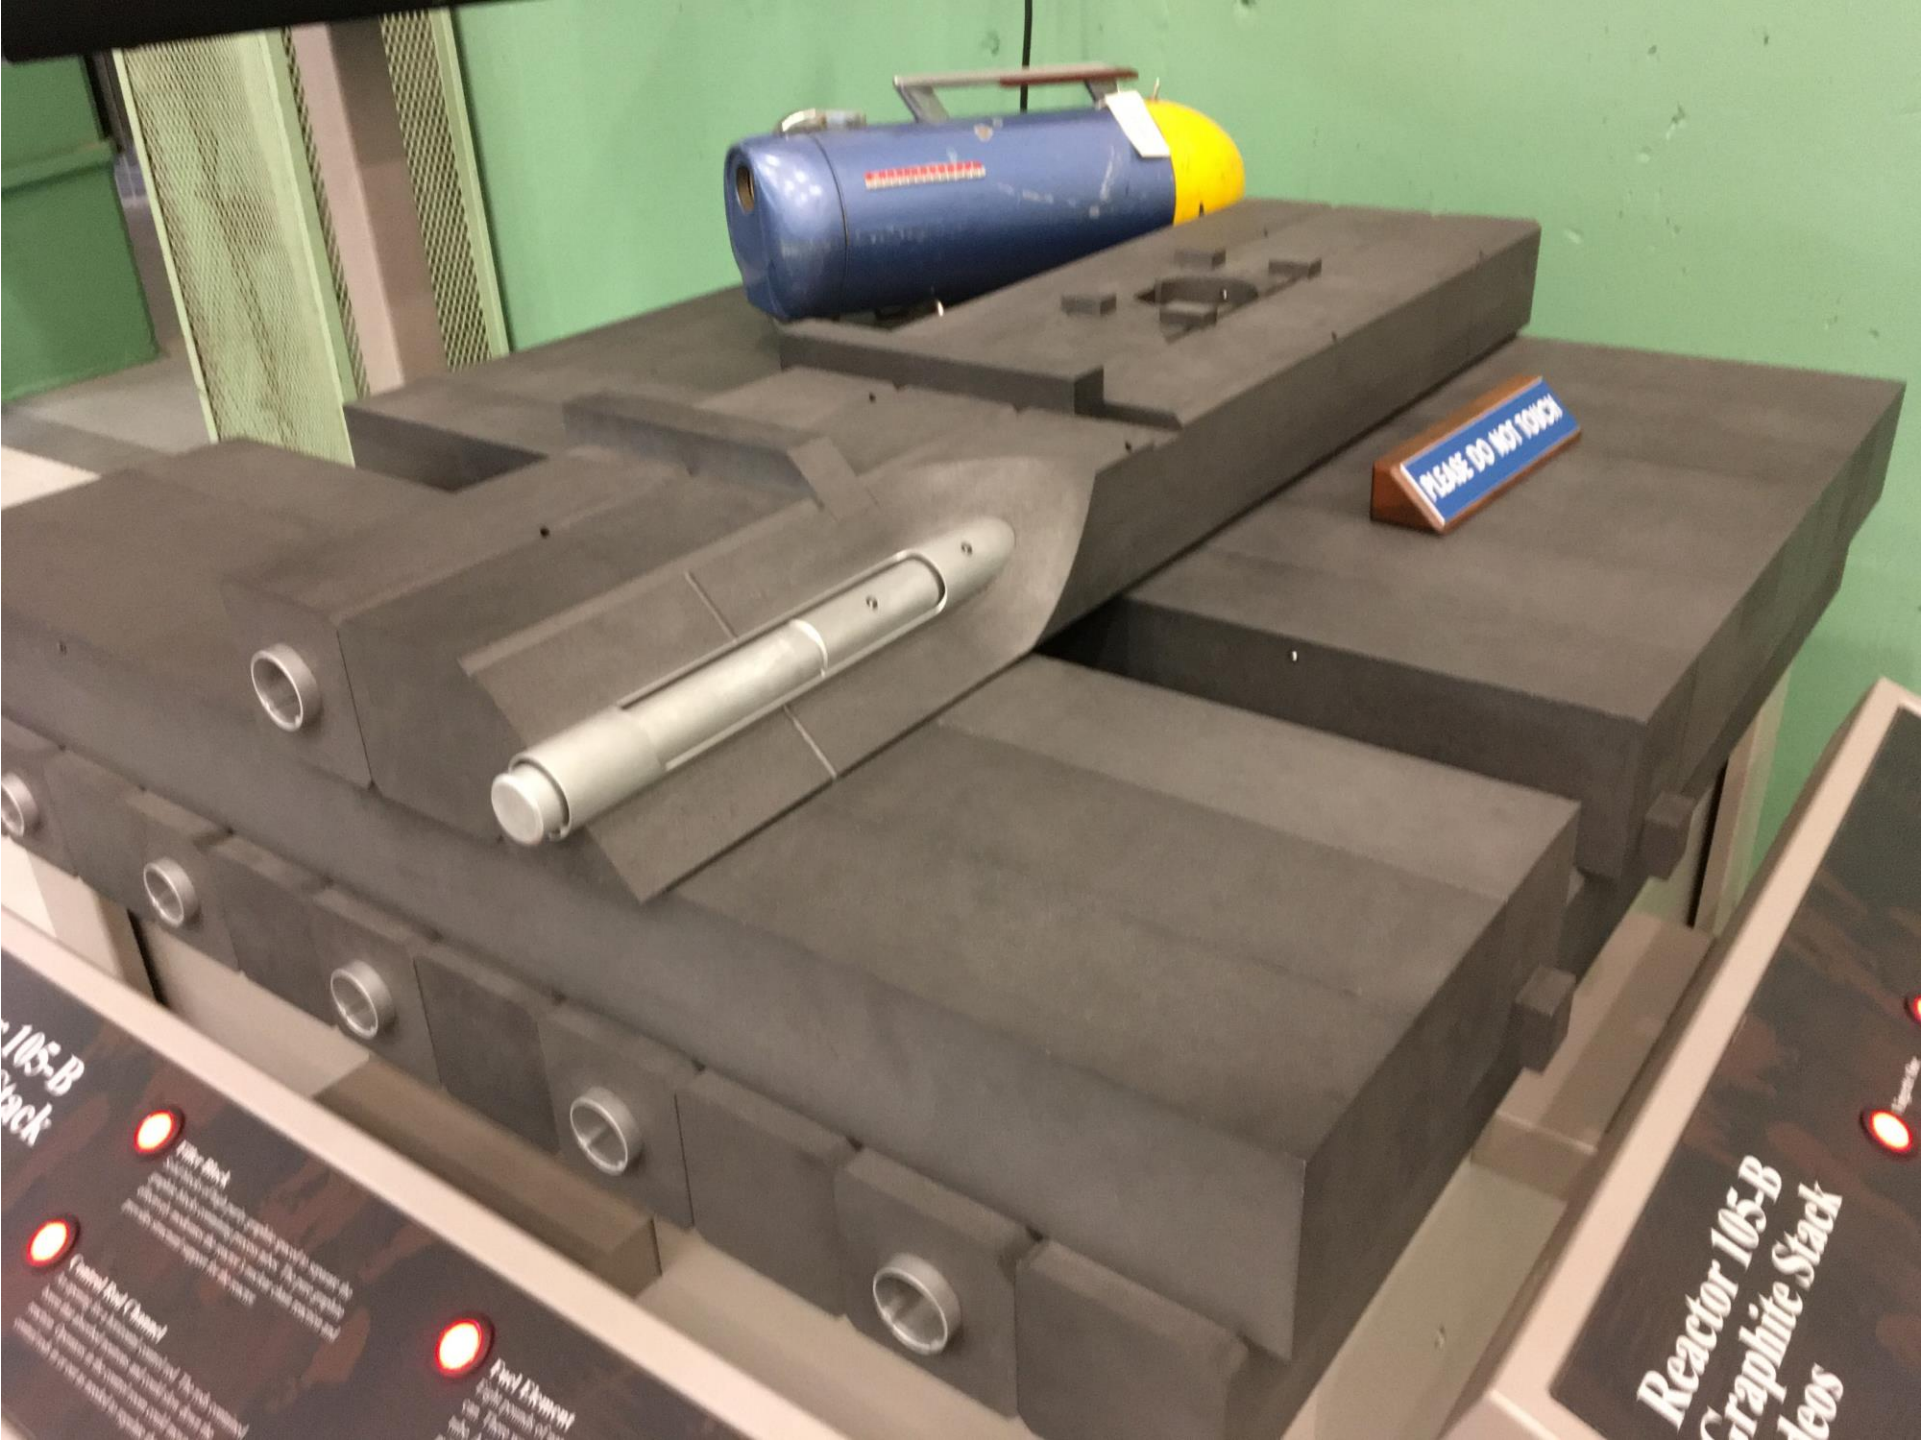
Reactor 105-B
Graphite Stack

Control Rod
The control rods are used to regulate the rate of the nuclear reaction. They are made of a material that absorbs neutrons, preventing them from causing further fission. The control rods are inserted into the reactor core and can be moved in and out to control the reaction.

Graphite Moderator
The graphite moderator is used to slow down the neutrons produced in the nuclear reaction. This is necessary because the neutrons must be slowed down in order to cause further fission. The graphite moderator is made of a material that does not absorb neutrons, allowing them to be slowed down without being lost.

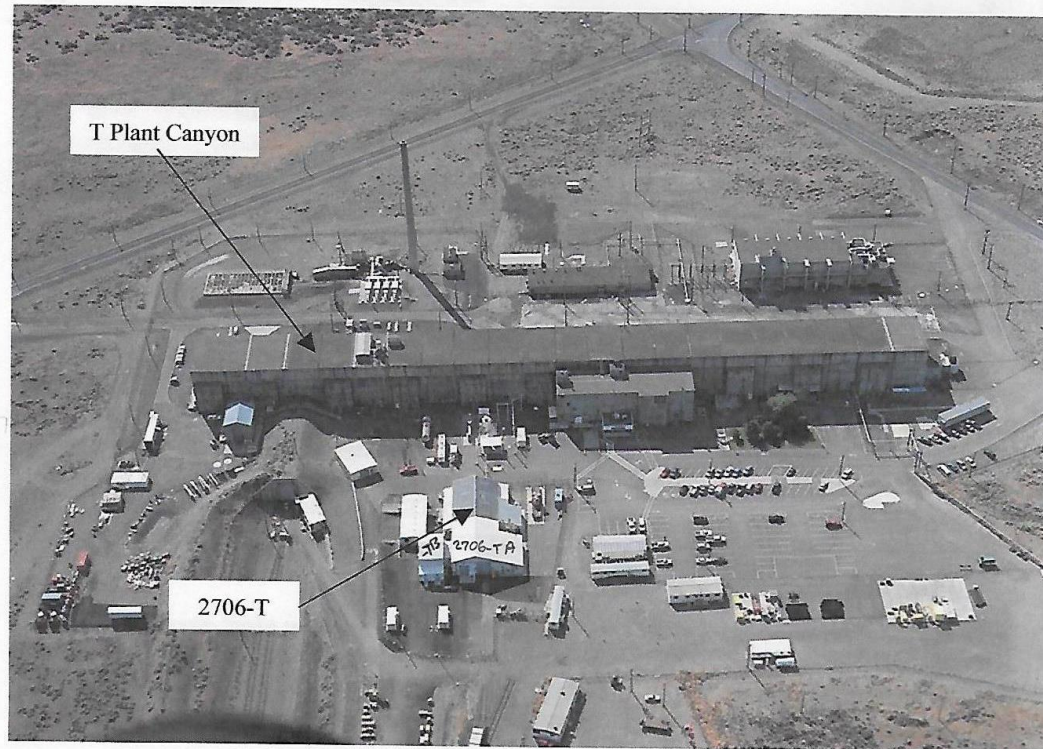
Figure 2.11. View of the T Plant Complex with 2706-T Facility and the T Plant Canyon Noted

Inspection, verification, opening, sampling, sorting, and limited treatment and repackaging of LLW, MLLW, and TRU waste are performed in the 2706-T Facility and other areas in the T Plant Complex. The 2706-T Facility, initially constructed during 1959 and 1960, was remodeled in 1998 to expand decontamination and treatment capabilities.

Proposed New/Modified Treatment Facility: Modified T Plant

In some MLLW alternatives and TRU waste alternatives, the T Plant Complex would be modified to establish the capabilities to treat/process waste for which no treatment capability currently exists. These waste streams include RH MLLW, MLLW in non-standard packages, RH TRU waste, CH TRU waste in non-standard containers, and PCB-commingled TRU waste. Specific capabilities provided by this modified T Plant would include stabilization, macroencapsulation, deactivation, sorting, sampling, repackaging NDE, and NDA.

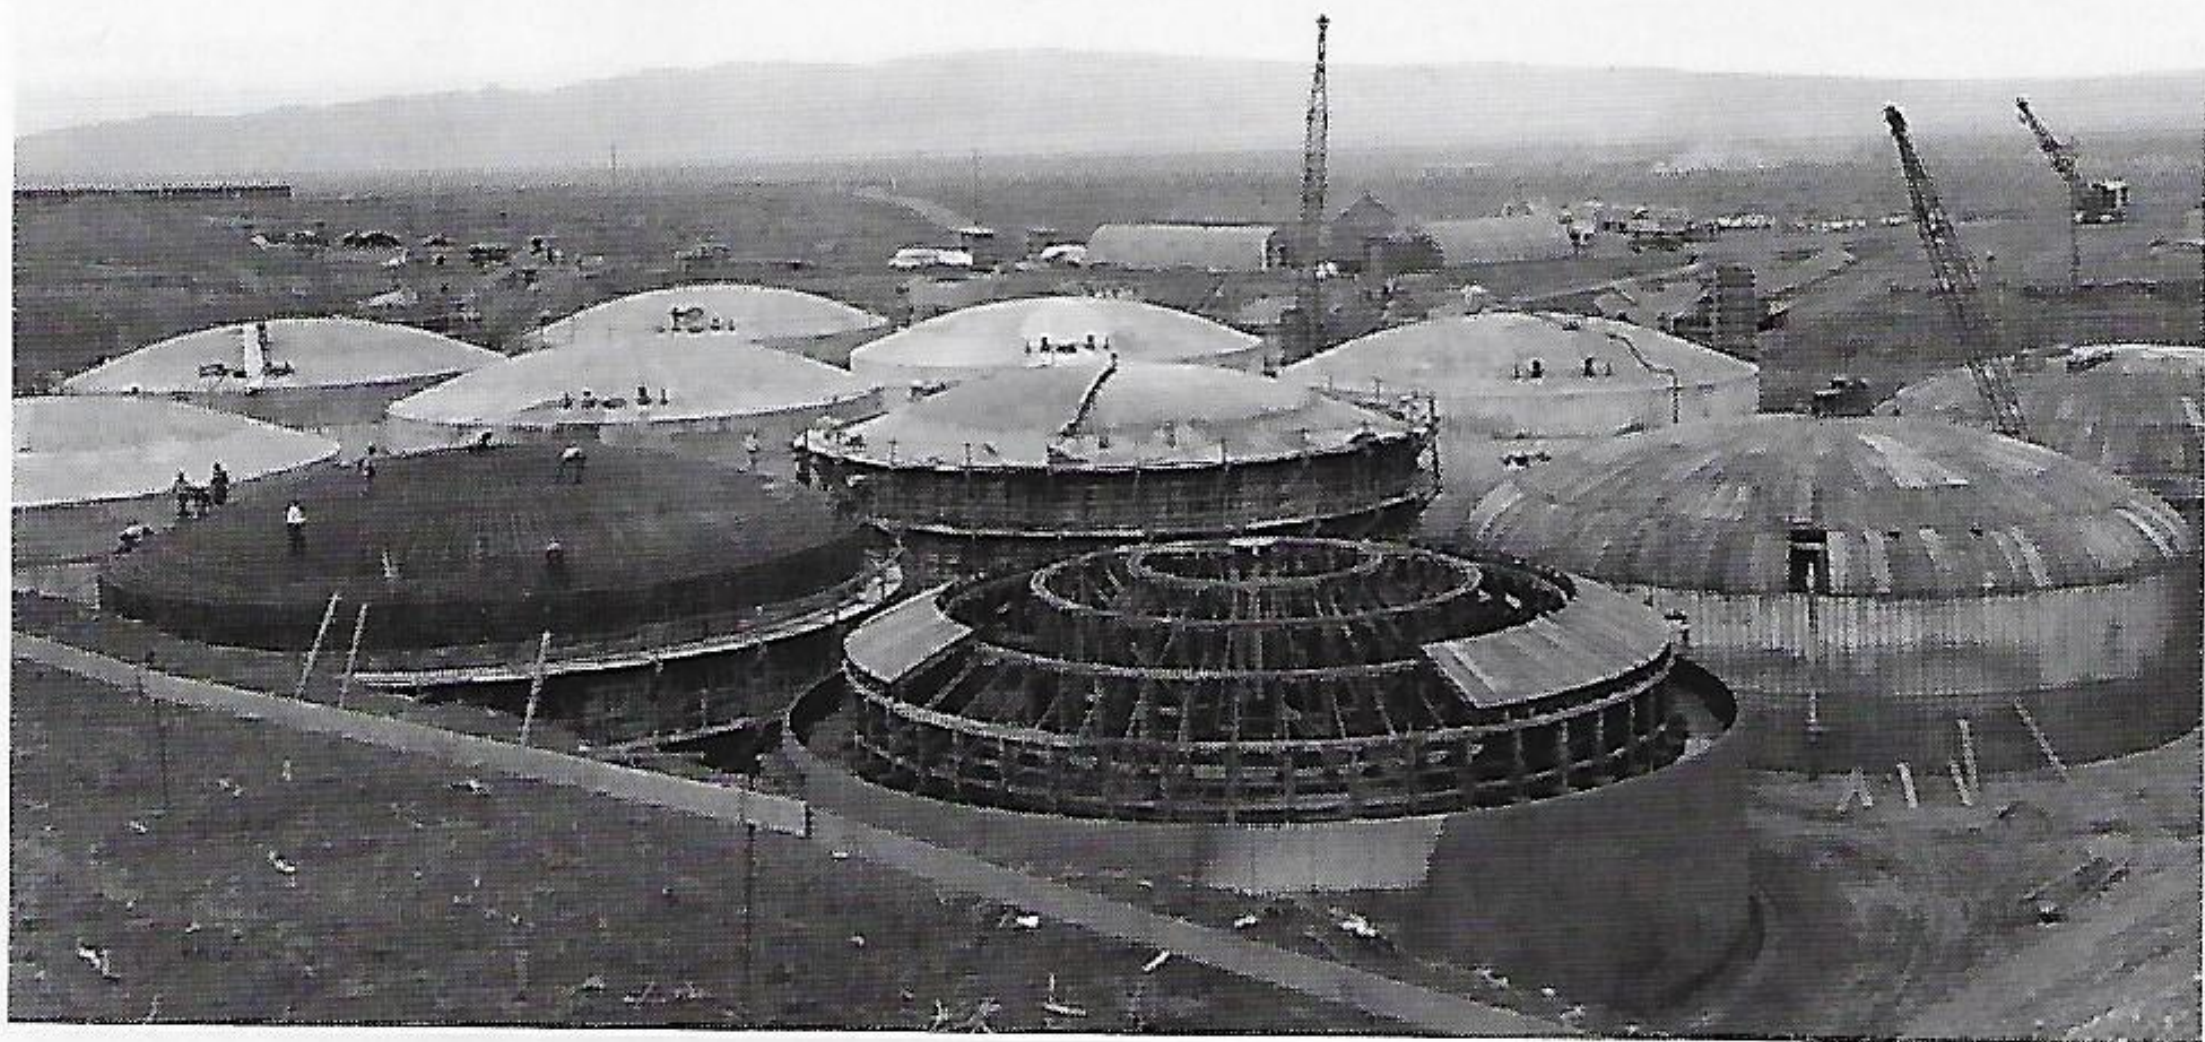
A tank farm on the Hanford reservation under construction

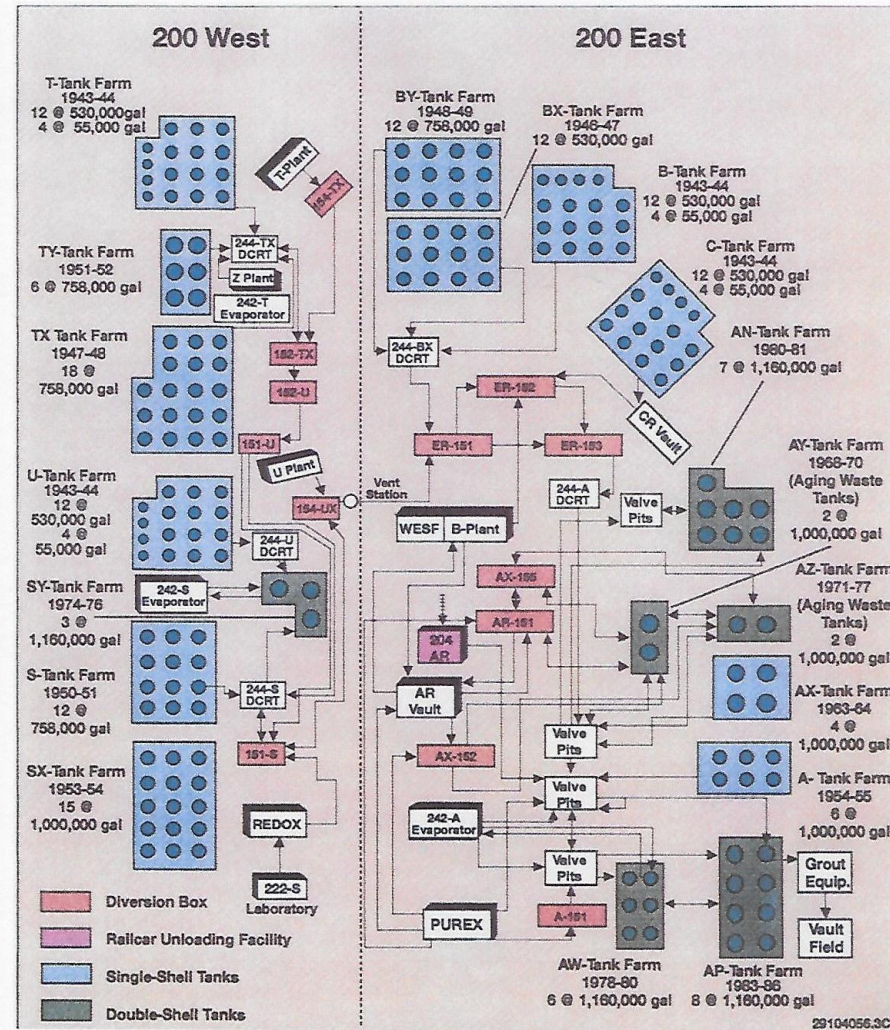
Figure 2.1. Hanford Site Tank Farms

Between 1943 and 1964, 149 SSTs were built for storing radioactive wastes generated by the chemical processing of irradiated reactor fuels. The SSTs are located in 12 tank farms in the 200 West and 200 East Areas on the Hanford Site. Figure 2.1 is a reference schematic of these SST farms and the associated six double-shell tank (DST) farms. The capacities of the SSTs range from 208 m³ (55,000 gallons) to 3,785 m³ (1,000,000 gallons). Carbon steel lines the bottom and sides of the reinforced concrete shell of each tank. The tanks are below grade with at least 6 feet of soil covering them. A sketch of a typical SST is provided in Figure 2.2.

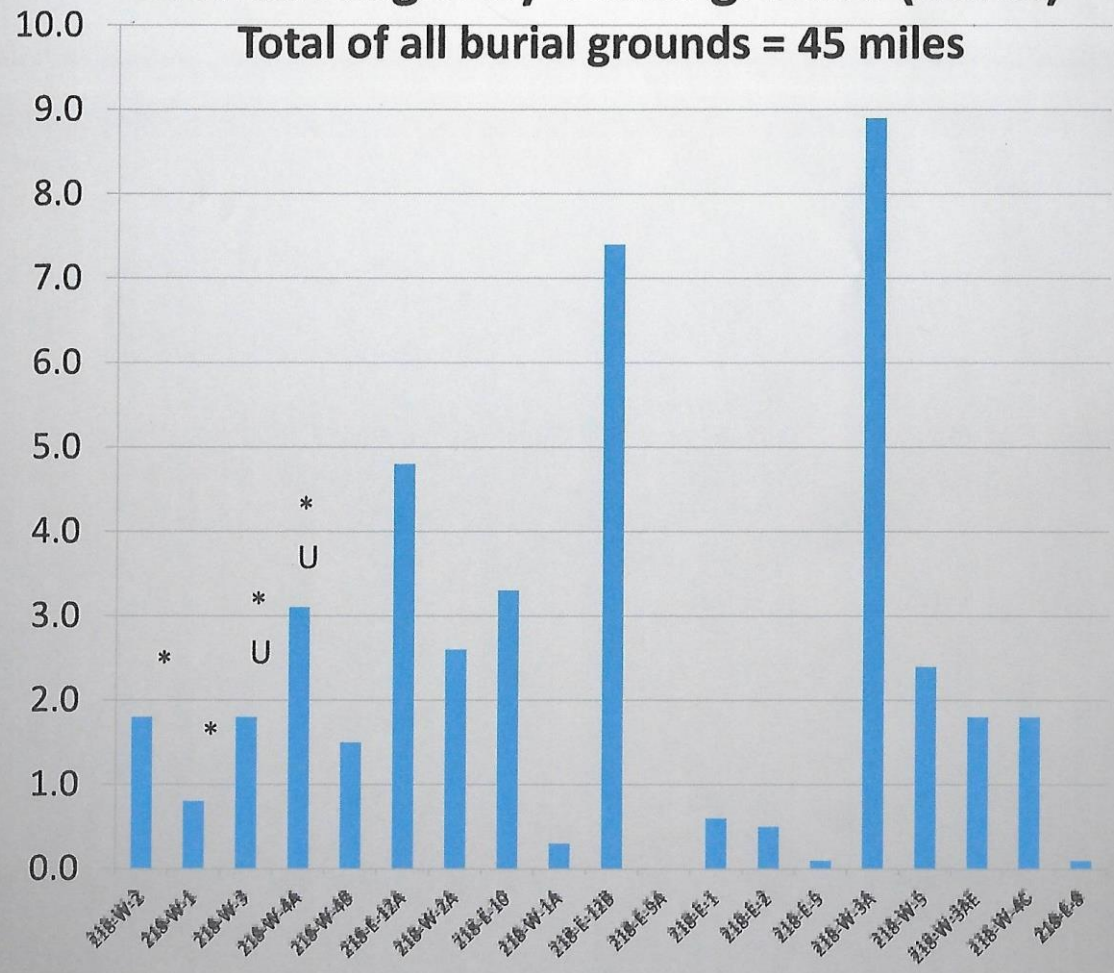
Trench length by burial ground (miles)

Total of all burial grounds = 45 miles

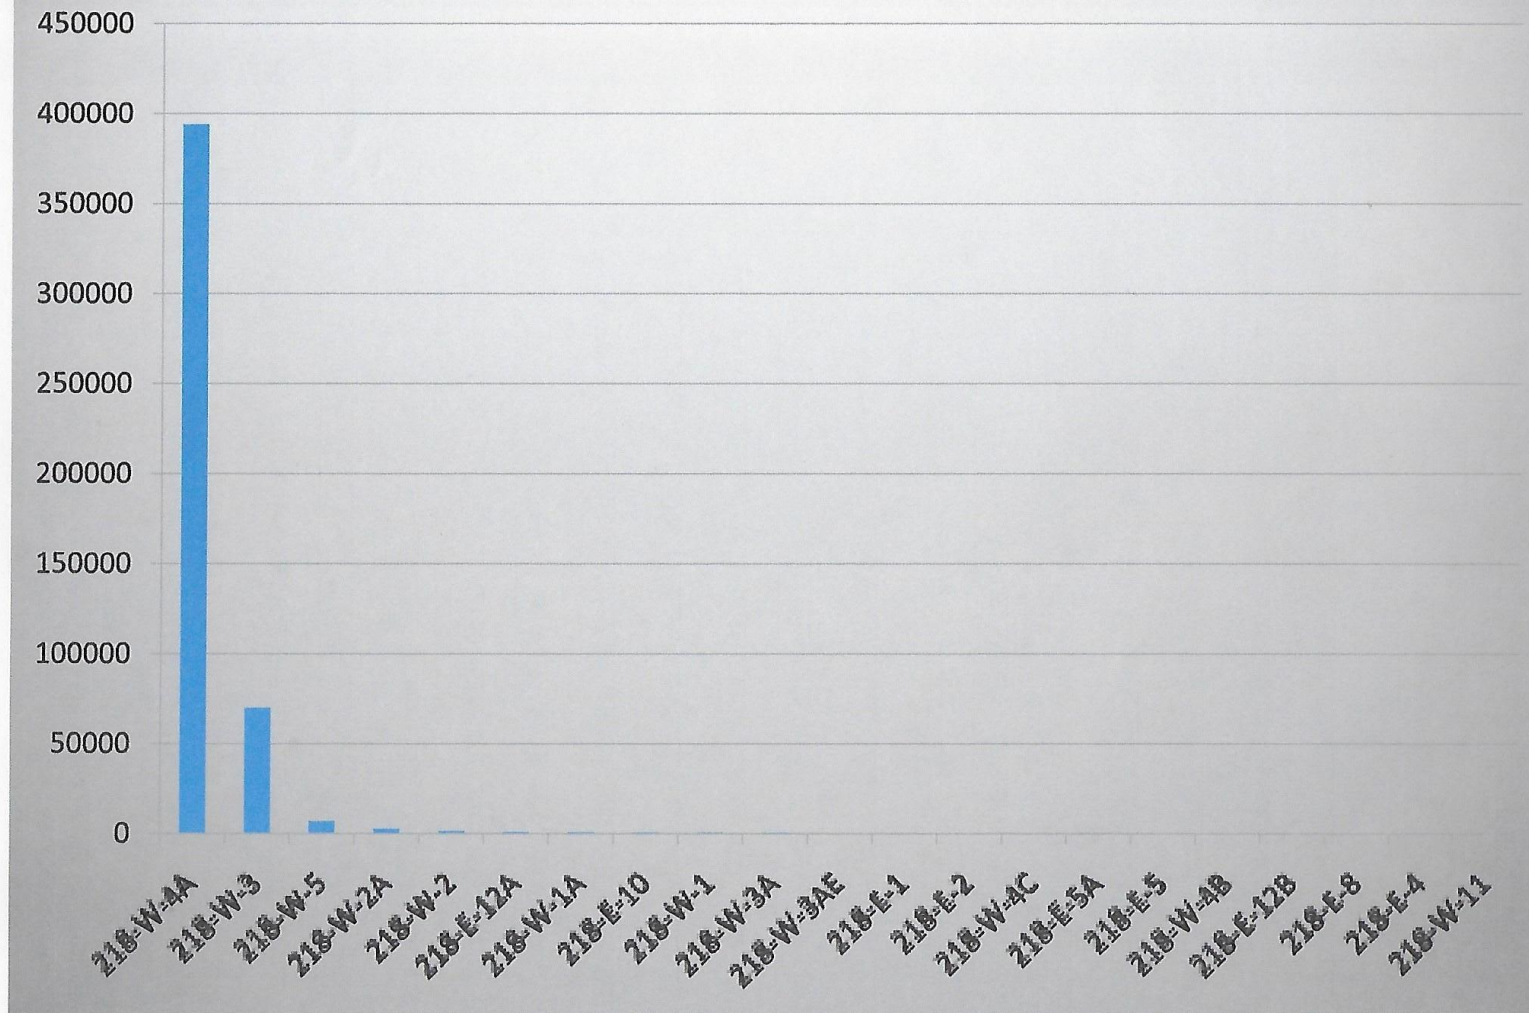
Uranium inventory by burial ground (kg)

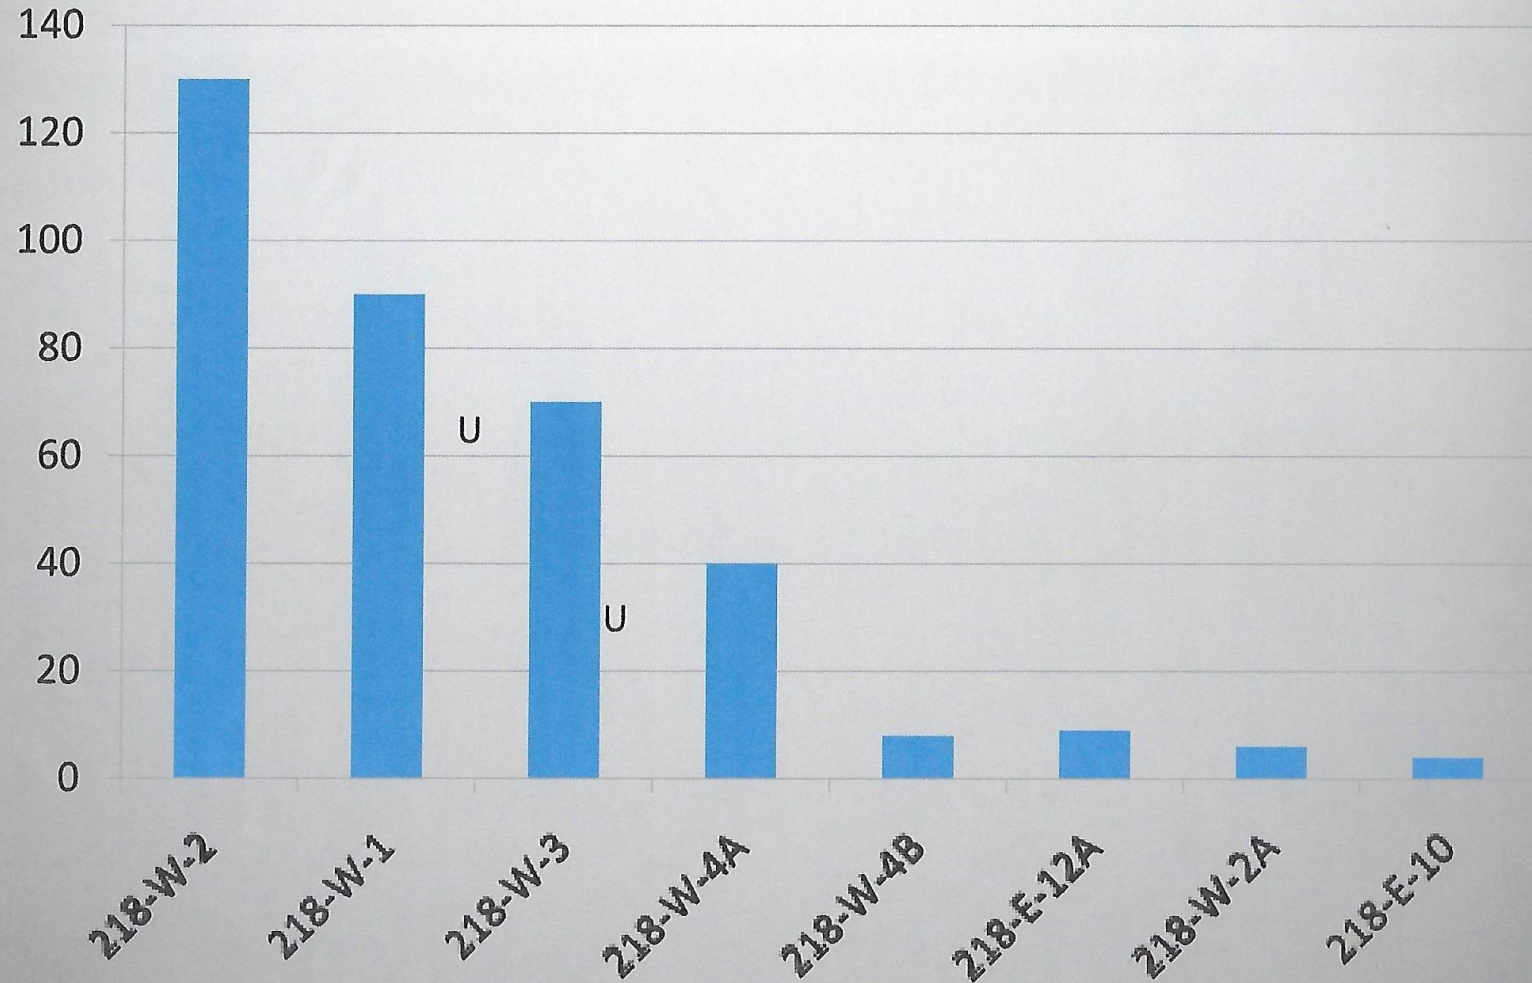
Plutonium inventory by burial ground (kg)
